Meeting Minutes

Project: I-29 Exit 77 (41st Street) Interchange Study and Environmental Assessment

Subject: Carolyn Avenue Alternatives

41st Street Corridor Environmental Assessment

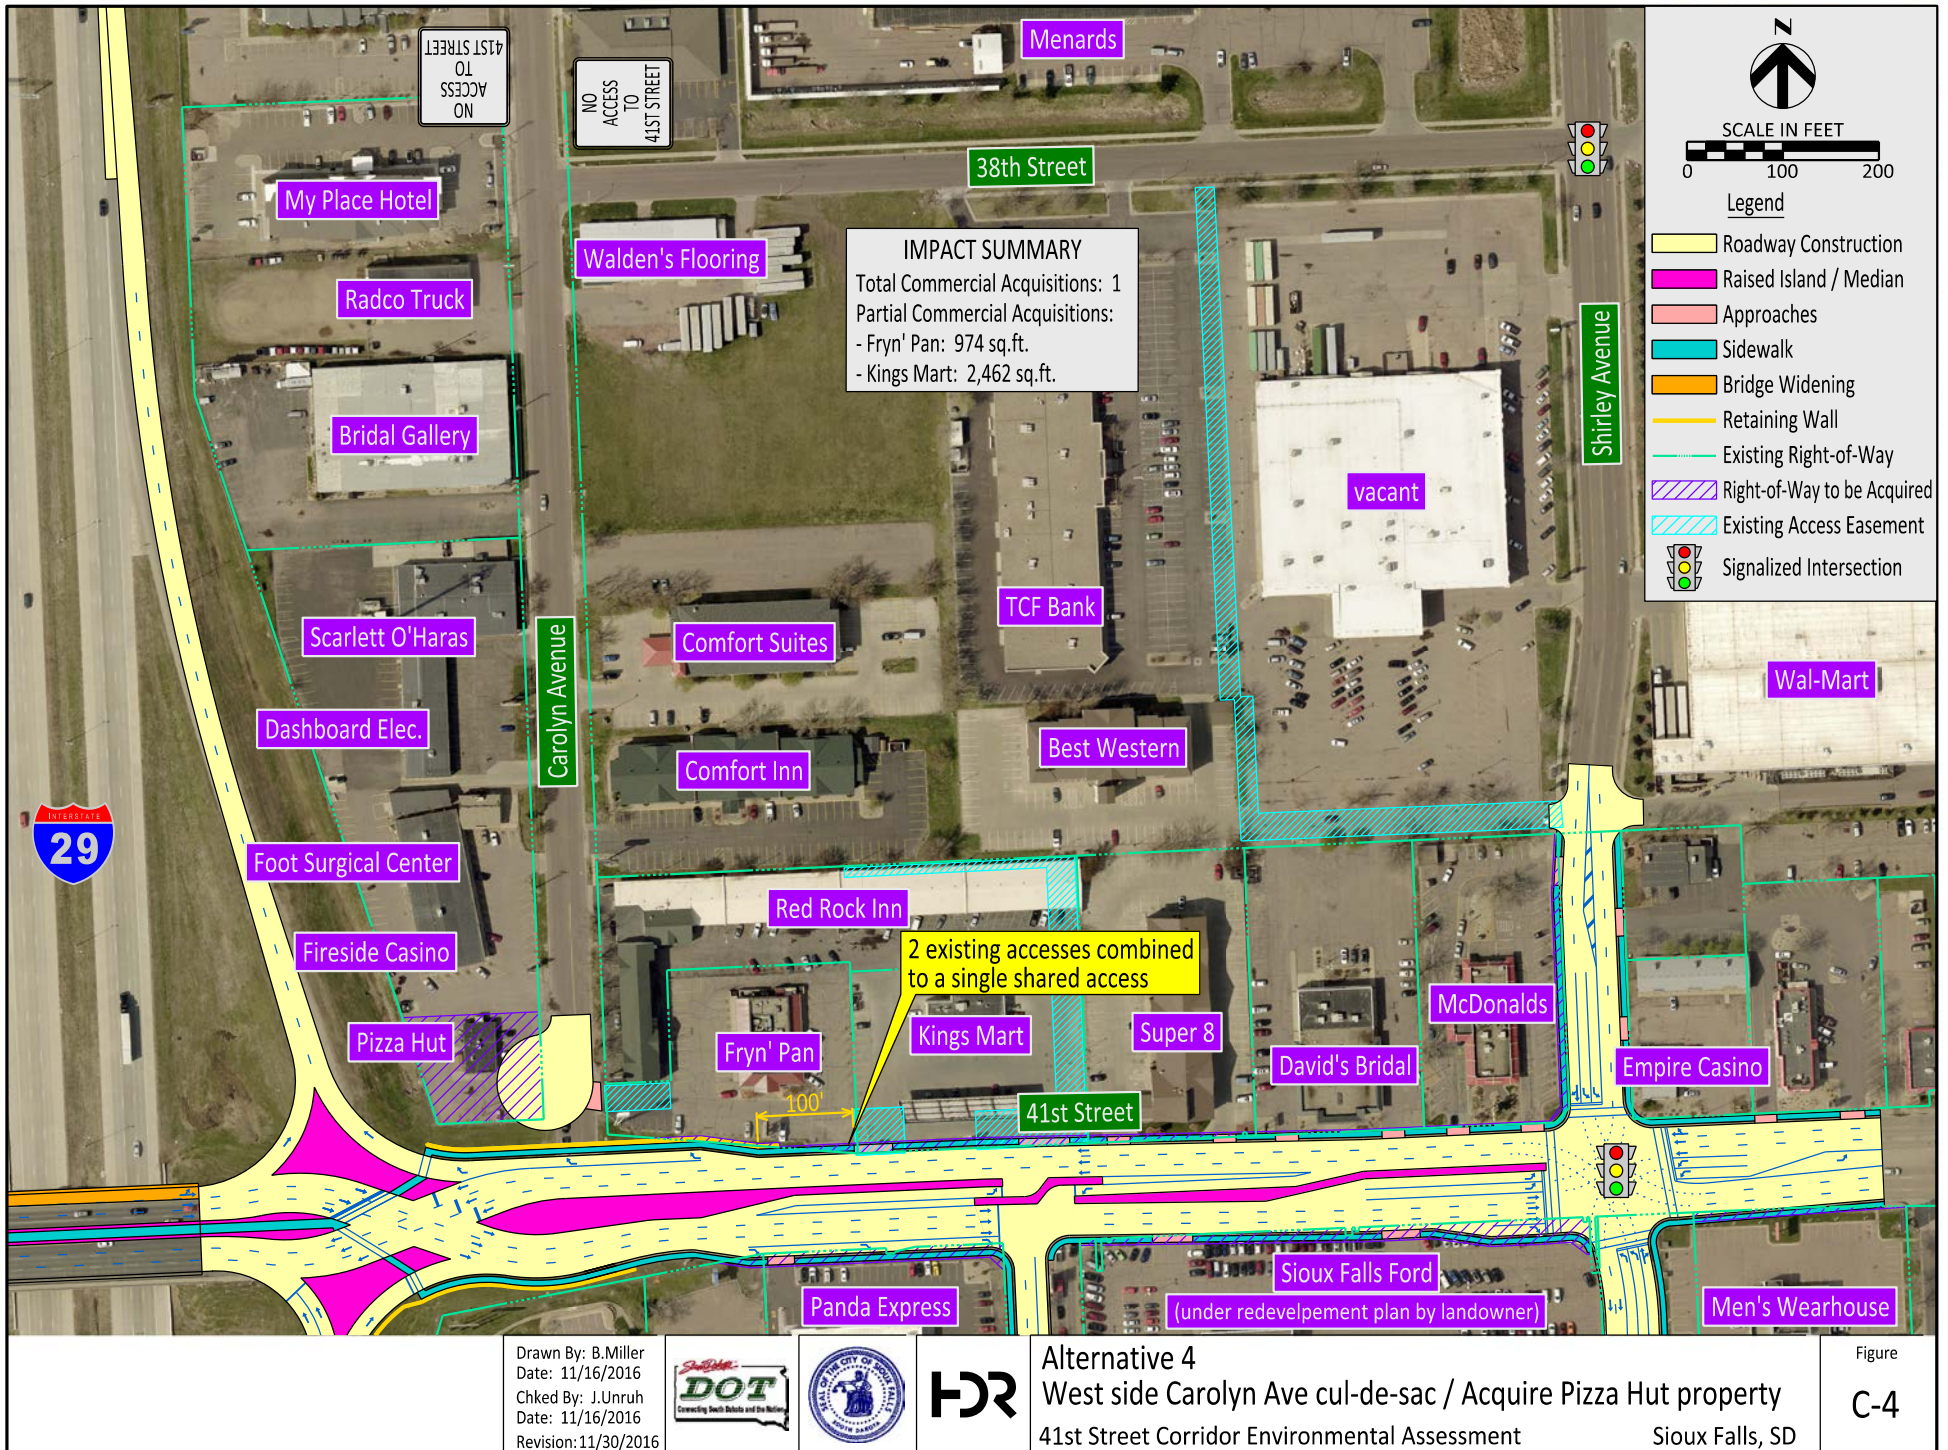
Figure
C-4

Alternative 4
 West side Carolyn Ave cul-de-sac / Acquire Pizza Hut property
 41st Street Corridor Environmental Assessment
 Sioux Falls, SD

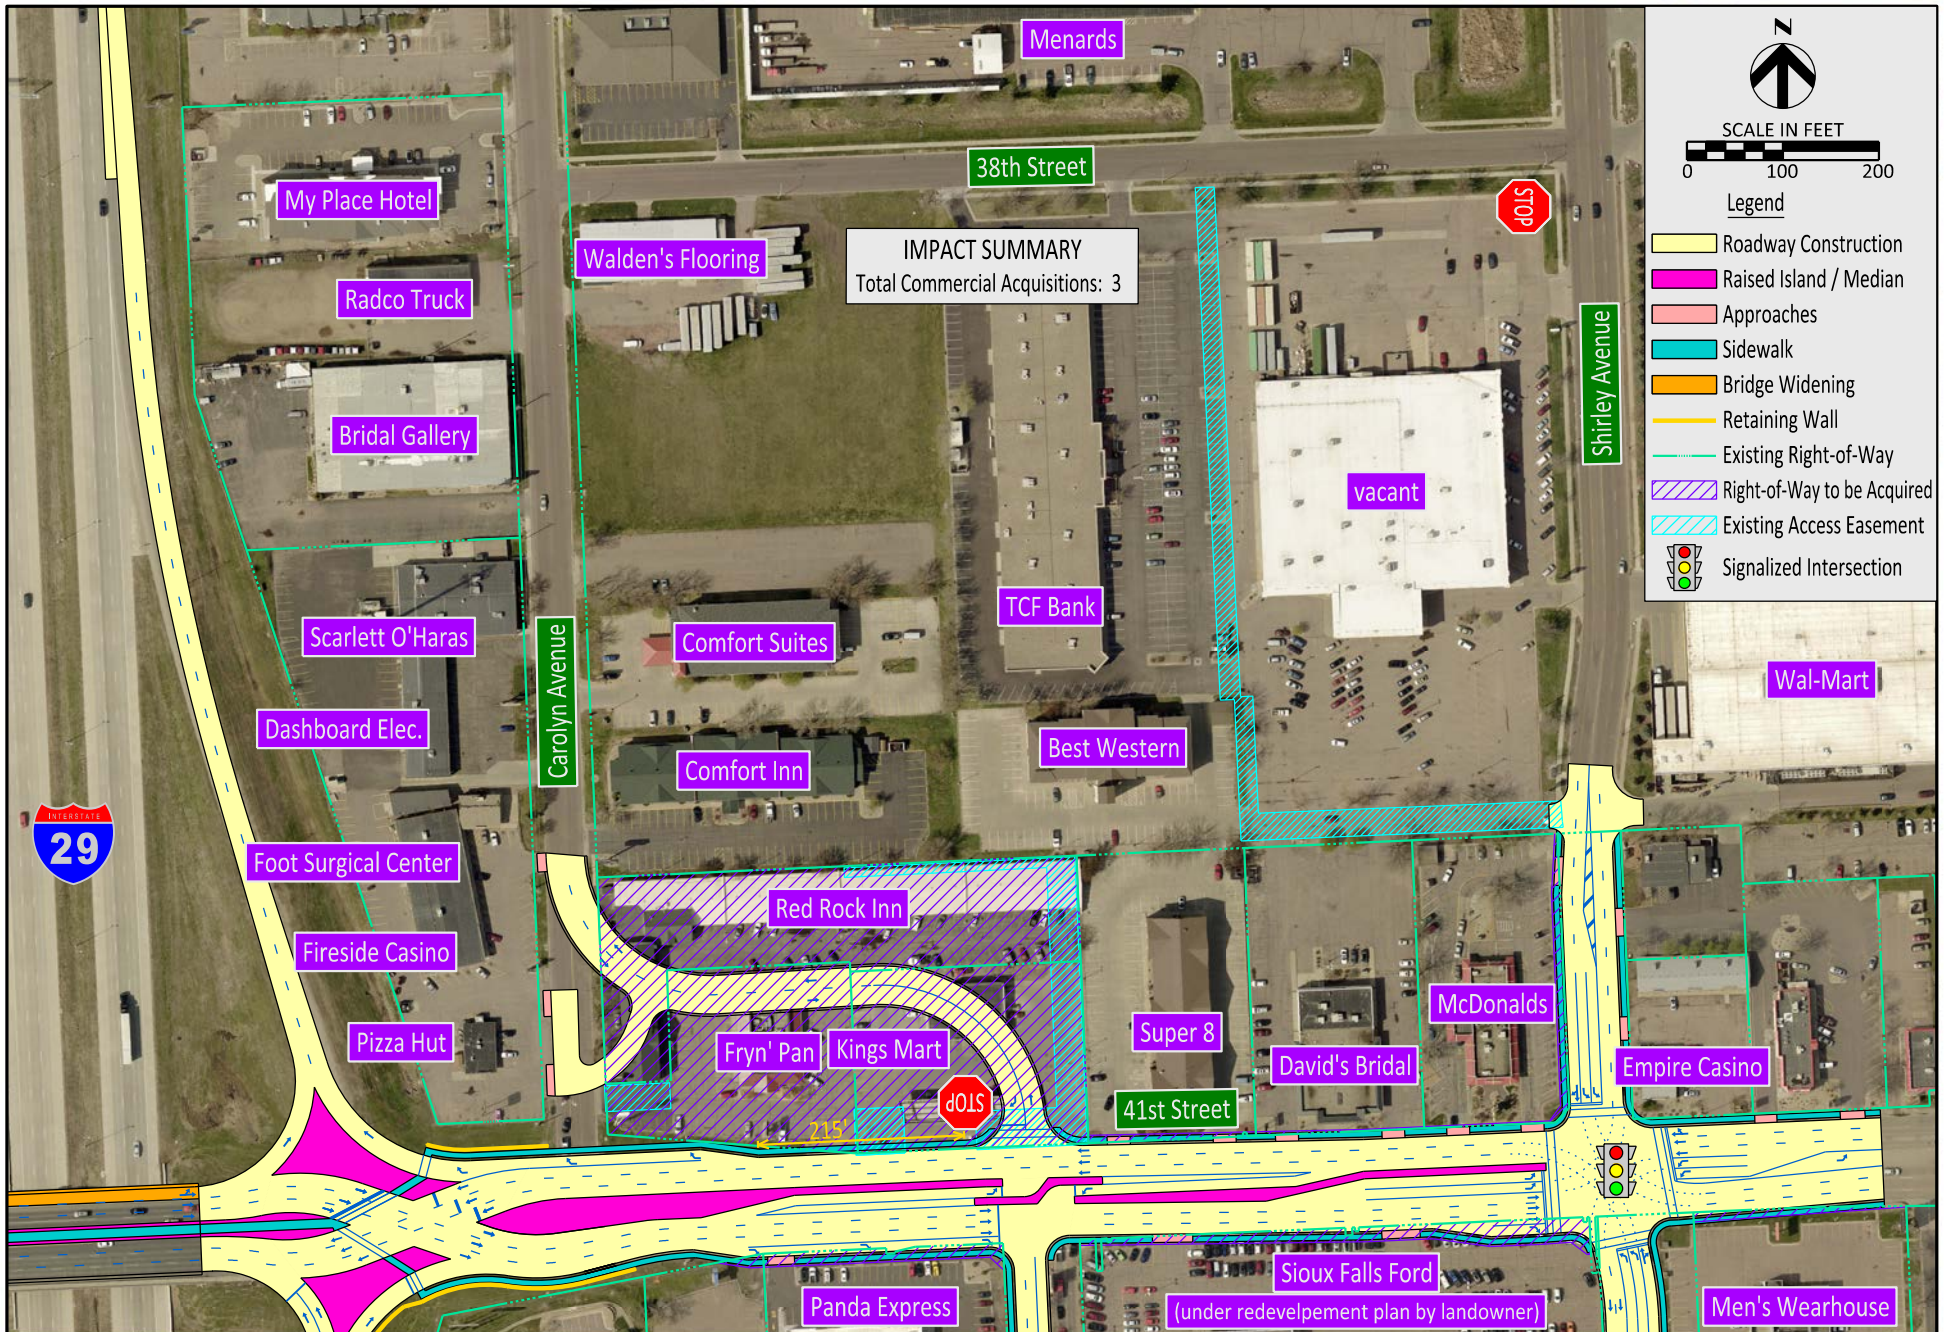
Figure
C-6

Alternative 6
Realigned Carolyn Ave to Mall Entrance
41st Street Corridor Environmental Assessment

- Add Alternative 6 with realignment of right-in/right-out Carolyn Avenue and acquisition of Red Rock Inn, Fryn' Pan, and Kings Mart properties. This is likely the only way that adequate separation from the interchange ramp could be provided. FHWA would probably only approve this $\frac{3}{4}$ access alternative.

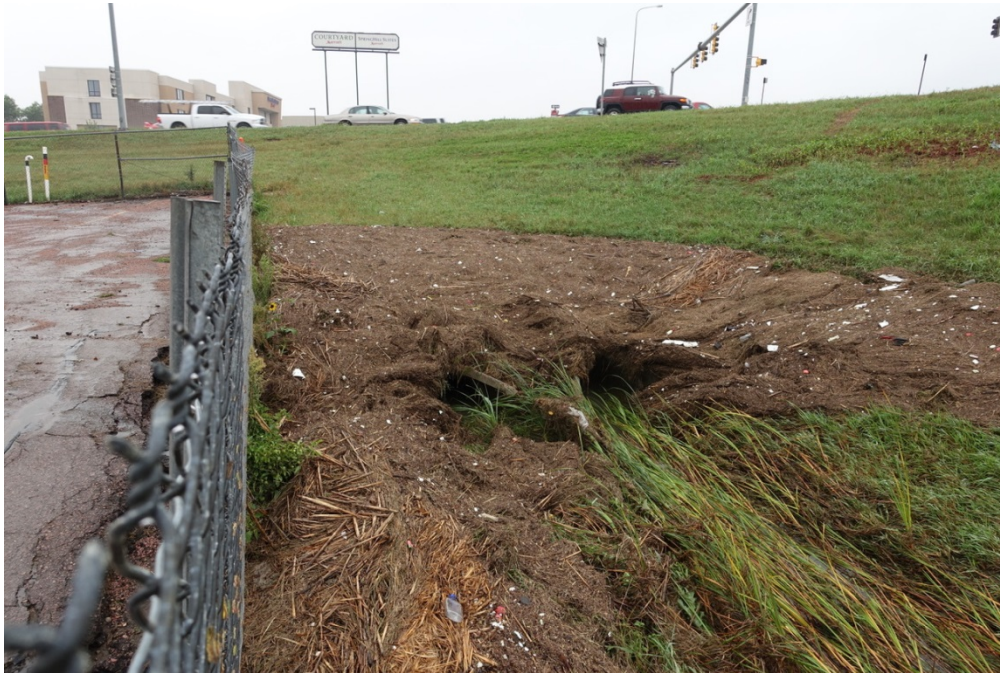
8/28/15 Post flood photos at 42" culverts at I-29 NB ramp west of Carolyn Avenue

Photo looking
south toward
41st Street

- 3.1 Pizza Hut's lease on Chuck's property expires in September 2017. Pizza Hut is concerned about the Carolyn Avenue site because of the out-dated building and small site size.
- 3.2 Chuck informed the group that the dual 42" culverts under 41st Street along the I-29 northbound ramp frequently plug up with debris and vegetation due to inadequate maintenance. Chuck stated that he has brought this to the attention of SDDOT. Photos provided by Chuck are in **Attachment 2**.

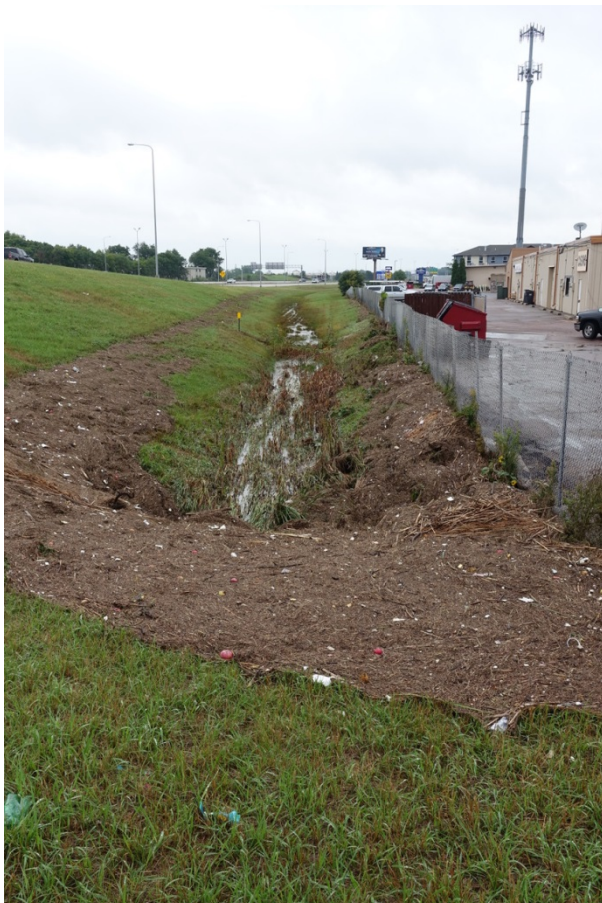
Photo looking
north along east
side of I-29 ramp
